M. E. Williams and Associates, Inc.

Report Number: 16-4686

Failure analysis of two steam coil sections used in a steam heating system, and analysis of two water samples removed from the system containing the failed coils. The water samples were examined by visual examination, scanning electron microscopic examination, energy dispersive x-ray analysis, and anion analysis. The copper tubing in the failed coil samples was examined by visual examination, scanning electron microscopic examination, energy dispersive x-ray analysis, and metallographic examination.

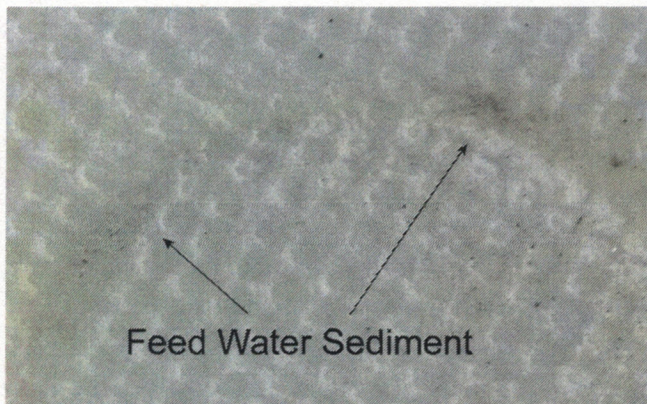
Figure 1 – Feed Water Sediment from Front by Dock Water Sample

There was a small amount of sediment in the feed water sample labeled Front by Dock. Some of the sediment is shown in Figure 1.

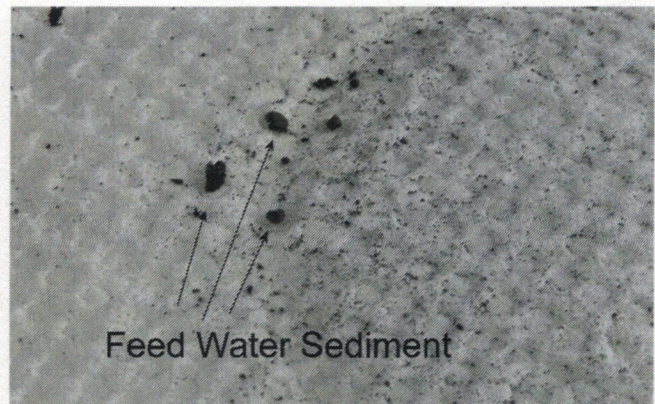
Figure 2 – Feed Water Sediment from CIP Water Sample

There was considerably more sediment in the CIP Water Sample. Some of that sediment is shown in Figure 2. Figure 3 shows some of the sediment sticking to a magnet, indicating that the black material in

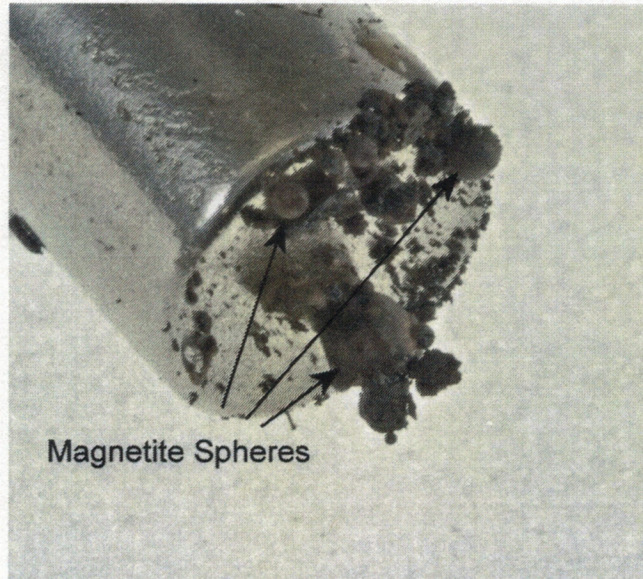
the sediment was magnetite, magnetic iron oxide (Fe₃O₄). Some of the magnetic iron oxide is in the form of spheres.

Figure 3 – Sediment from CIP Water Sample

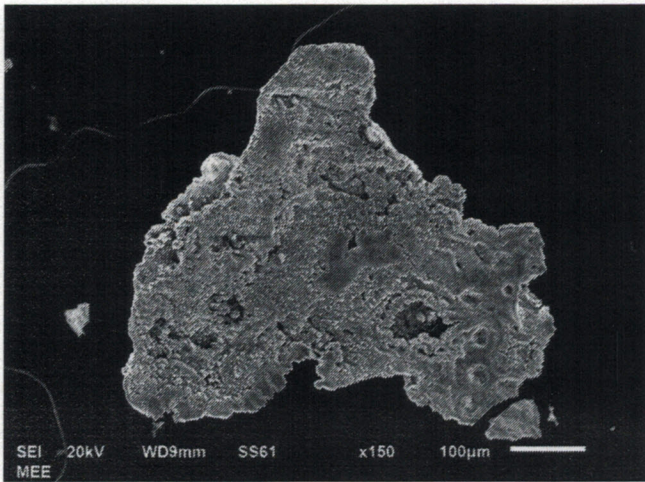
Figure 4 – 150X Feed Water Sediment, Front of Dock Sample

The presence of aluminum is a potential problem with the feed water.

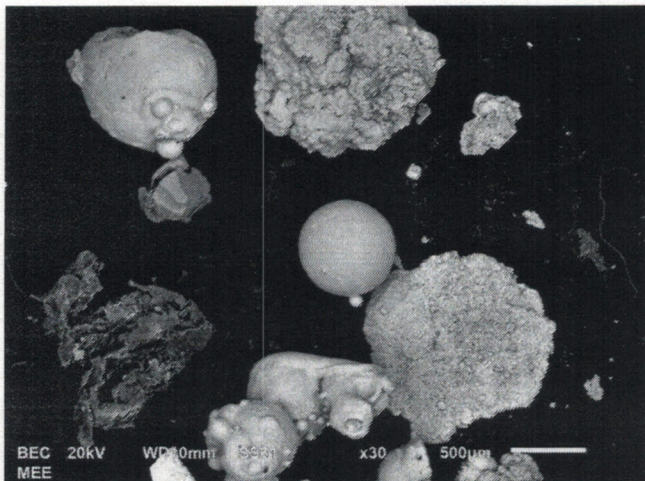
Figure 10 – 30X Feed Water Sediment CIP, Area 1

The sediment from the CIP location was somewhat different than that from the Dock location. Figure 10 shows the variety of structures that were found. Figure 11 shows the locations of the analysis. The spectra are shown in Figures 12 through 16, and the semi-quantitative analysis is given in the table that follows.

Location 1 appears to be a piece of carbon steel. Aluminum and titanium are often used as grain refiners in steel. Locations 2 and 3 are iron oxide nodules. Location 4 is a piece of copper oxide scale. Location 5 is an iron rich organic material. Each of these particles were formed as a result of corrosion in the system. A likely source of the aluminum is the steel piping and tubing in the system.

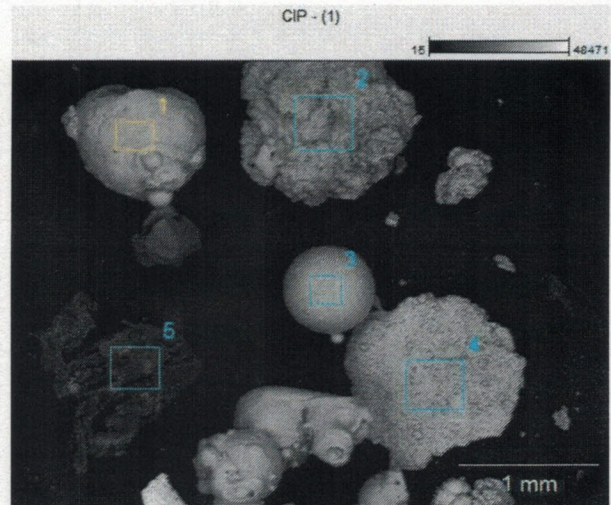
Figure 11 – 30X Analysis Locations, CIP Water Sediment, Area 1

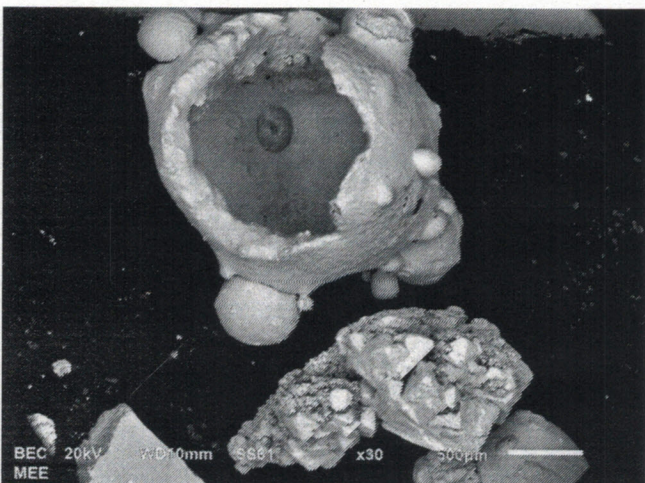
Figure 17 – 30X Feed Water Sediment CIP, Area 2

The hollow nodule shown in Figure 17 indicates there may be bacteria in the feed water. The pH of the feed water may be high enough to prevent bacteria growth, but localized pH may allow bacterial growth. Location 3, Figure 18, had to be reanalyzed to obtain a good spectrum, because the x-rays were blocked by the hollow nodule. The reanalysis is reported as Location 4 in the table and spectra that follow. The semi-quantitative analysis is given in the table that follows.

The hollow nodule, Location 1, appears to be oxidized steel. Location 2 is iron oxide, and Location 4 is a group of copper oxide crystals. Aluminum was present in all three locations.

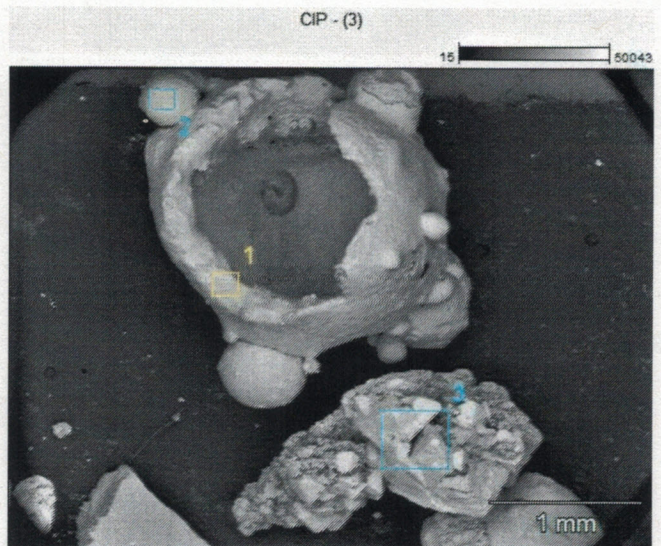
Figure 18 – 30X Feed Water Sediment CIP, Area 2, Analysis Locations

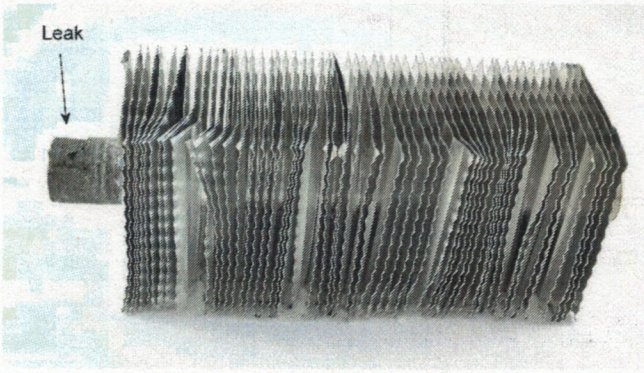
Figure 22 – Coil Sample 1

Figure 22 shows Coil Sample 1. The leak was on the top side of the tube, and the tube was located on the top of the coil. It was the last tube that the steam would pass through in the coil. There was considerable thinning of the copper tubing associated with the leak, Figures 23 and 24. Thinning of the tubing is usually the result of fine water droplets in the steam that impinge on the surface and cause erosion. Figure 25 shows cracks on the inside diameter of the tube. This sample was from the tube on the right in Figure 24. Cracking was likely the result of embrittlement of the copper tube and had nothing to do with erosion.

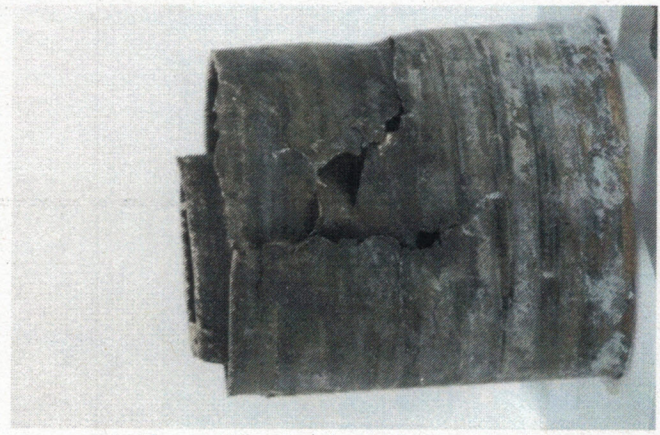
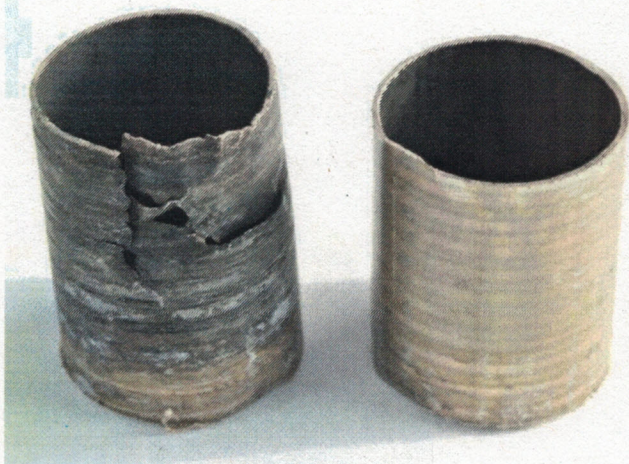
Figure 23 – Leak, Coil Sample 1

Figure 24 – Tube Sections, Sample 1

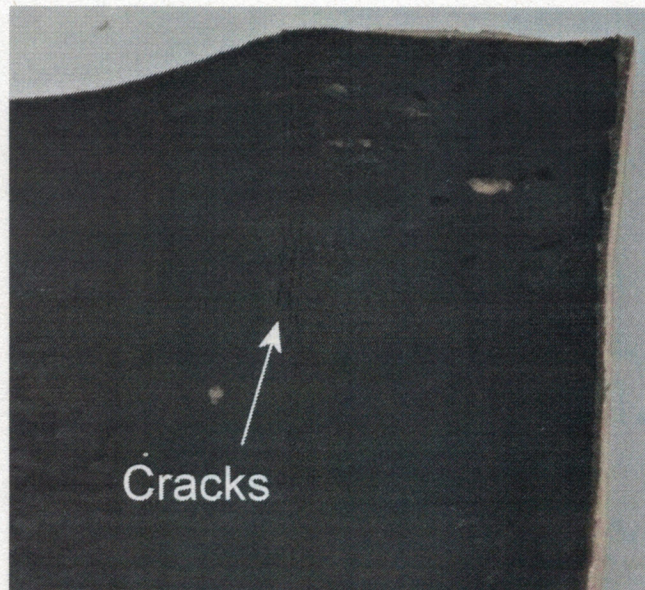
Figure 25 – Crack in I.D. Tube Sample 1

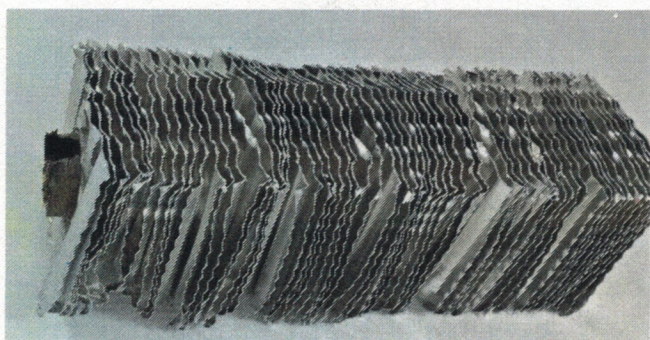
Figure 26 – Coil Sample 2

Coil Sample 2, Figure 26, was also taken from the top row of the coil. The leak on the top side of the tubing appeared to be the result of thinning. Figures 27 and 28 show the leak, which was on the top side of the tube. The apparent cause of leakage was erosion due to condensate in the steam. The tube did not crack when it was opened for examination, Figure 29. What appears to be cracks was the result of the oxide scale flaking off.

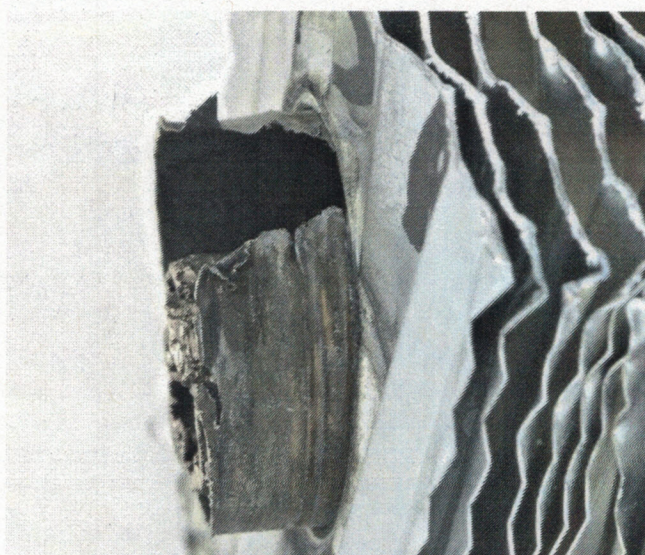
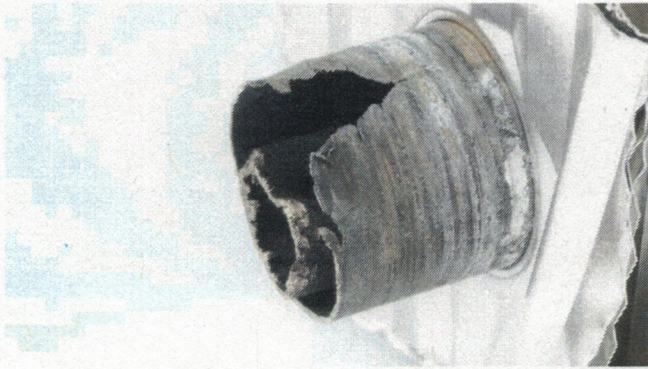
Figure 27 – Leak in Coil Sample 2

Figure 28 – Leak in Coil Sample 2

1. Replace the heat exchangers with heat exchangers fabricated from 304L stainless steel.
2. Check the steel tubing in the system by ultrasonic testing to determine the thickness of the steel tubing and piping, if they are accessible.

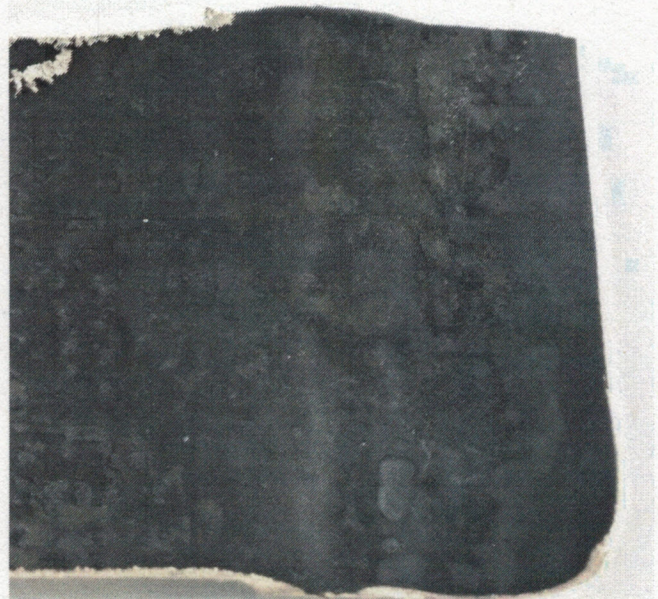
Figure 29 – Inside Diameter of Coil Sample 2

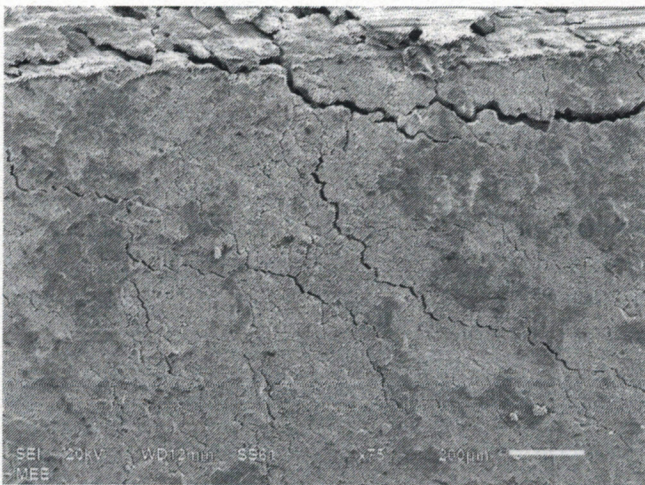
Figure 30 – 75X Intergranular Cracking I.D. Coil Sample 1

The cracking on the inside diameter of Coil Sample 1 is shown in Figure 30. The cracking mode is intergranular, which is a brittle fracture mode. The most common cause of intergranular cracking in copper

tubing is ammonia. Figure 31 is the spectrum of the surface shown in Figure 30. Only three elements are present: carbon, oxygen, and copper. Ammonia and other nitrogen compounds are very hard to detect by energy dispersive x-ray analysis, but the intergranular cracking is a key indicator that they were present.

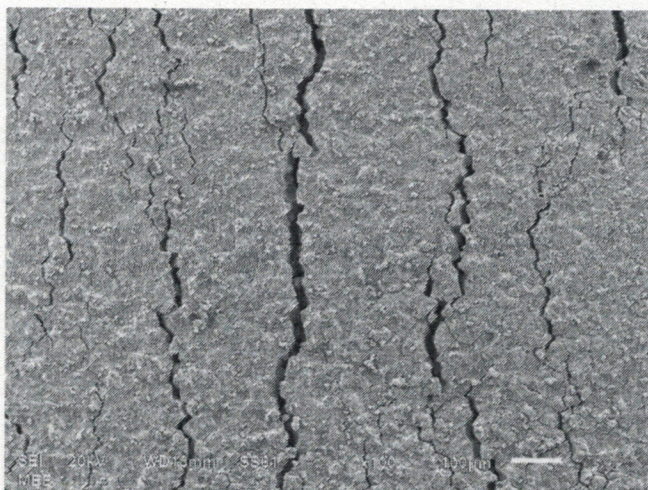
Figure 32 – 37X Intergranular Cracking on I.D. of Coil Sample 1

The intergranular cracking on the inside diameter of Coil Sample 1 is clearly shown in Figure 32. Figure 33 shows the nature of the oxide formation on the inside diameter of Coil Sample 1. Figure 34 is the energy dispersive x-ray spectrum of the surface area shown in Figure 32. This was the only location where aluminum was detected on the inside diameter of the copper tubing. The other elements were carbon, oxygen, and copper.

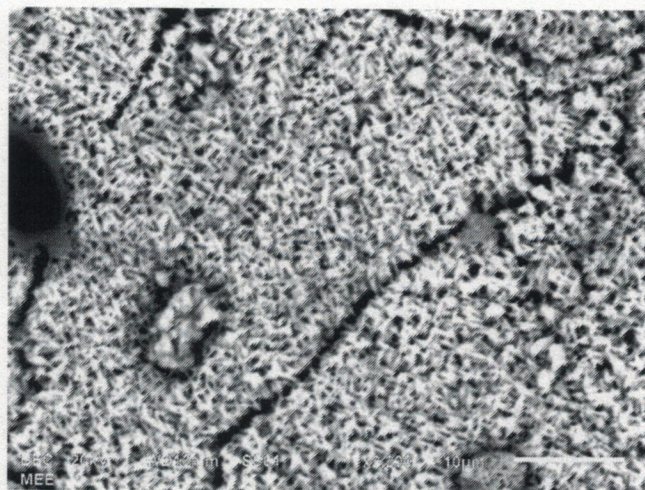
Figure 33 – 2200X I.D. Surface of Coil Sample 1

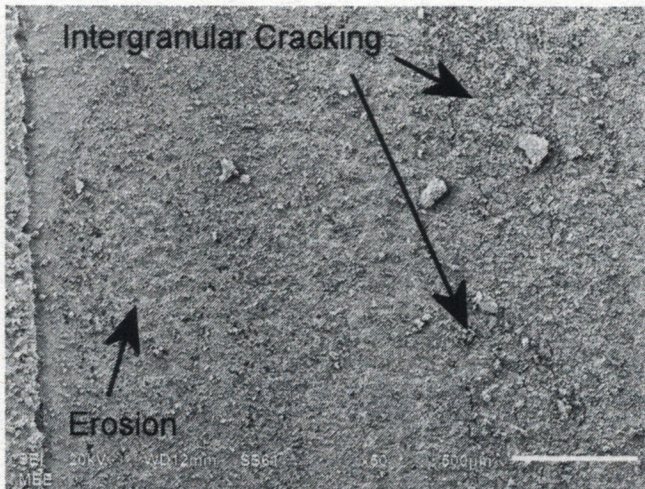
Figure 35 – 50X I.D. of Coil Sample 2

Figure 35 shows a location on the inside diameter of Coil Sample 2. The thick oxide scale had flaked off the copper at this location. There was evidence of erosion and evidence of intergranular cracking present. Figure 36 shows the spectrum of the area shown in Figure 35. The elements present were carbon, oxygen, and copper.

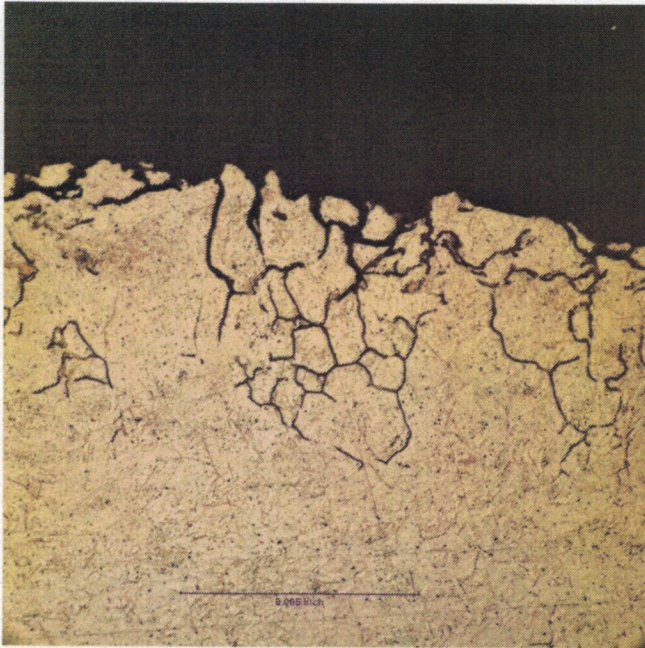
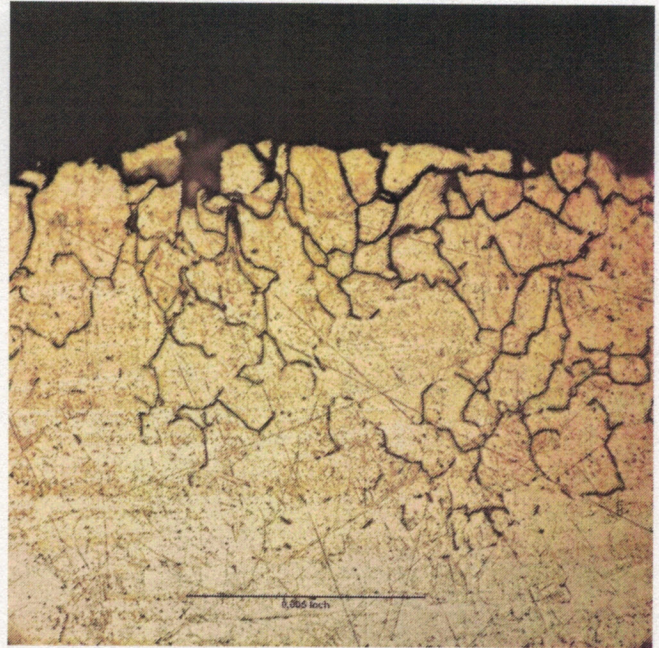
Figures 37 and 38 show intergranular stress corrosion cracking in the copper from Coil Sample 1. The intergranular stress corrosion cracking occurred in most locations on the inside diameter of the tube. There was thinning at the top of the tube. The bottom of the tube did not show thinning. Intergranular stress corrosion cracking destroys the metallic bonds at the grain boundaries, as shown in the photos. Any force to the grains will likely cause them to break free from the tube surface. The combination of erosion and intergranular stress corrosion cracking would result in rapid thinning of the copper tubing.

Figure 37 – 400X Intergranular Stress Corrosion Cracking of Top Side of Copper Tube from Coil Sample 1

Figure 38 – 400X Intergranular Stress Corrosion Cracking of Bottom Side of Copper Tube from Coil Sample 1

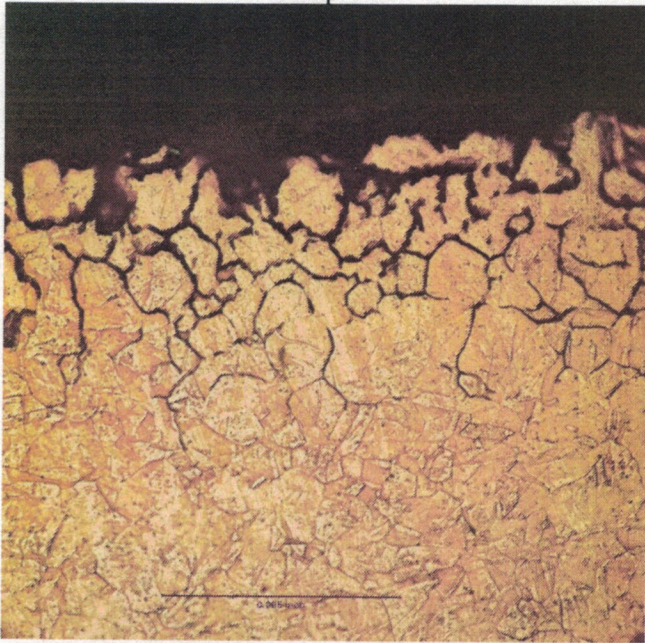
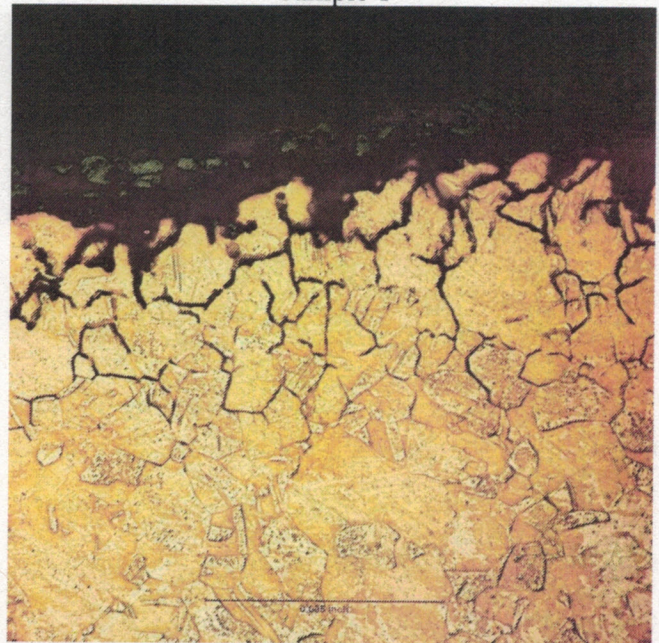
Figure 39 – 400X Intergranular Stress Corrosion Cracking of Top Side of Copper Tube from Coil Sample 2

Figure 40 – 400X Intergranular Stress Corrosion Cracking of Bottom Side of Copper Tube from Coil Sample 2

The copper tube from Coil Sample 2 showed the same conditions found in the sample from Coil Sample 1. The most common cause of intergranular stress corrosion cracking in copper is ammonia. Even at room temperature, moist ammonia will cause stress corrosion cracking in copper tubing.
