M. E. Williams and Associates, Inc.

Report Number: 16-4686

Failure analysis of two steam coil sections used in a steam heating system, and analysis of two water samples removed from the system containing the failed coils. The water samples were examined by visual examination, scanning electron microscopic examination, energy dispersive x-ray analysis, and anion analysis. The copper tubing in the failed coil samples was examined by visual examination, scanning electron microscopic examination, energy dispersive x-ray analysis, and metallographic examination.

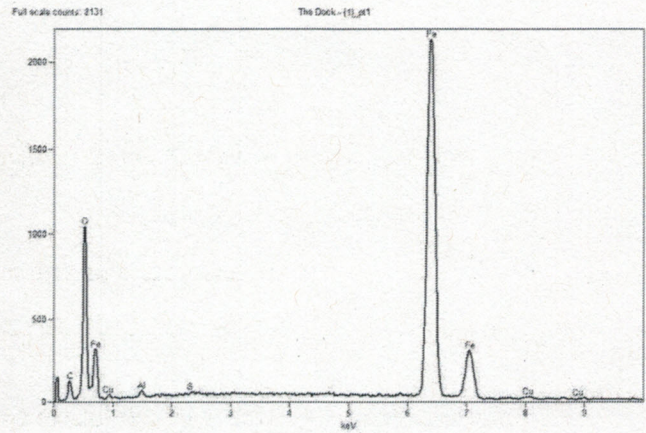
Figure 5 – Spectrum of Sediment shown in Figure 4 – Front of Dock Sample

Front of Dock Sediment Analysis (Percent by Weight)			
Element/Location	Figure 4	Figure 7 - 1	Figure 7 - 2
Carbon	2.7	3.7	0.7
Oxygen	13.6	7.7	21.4
Aluminum	0.4	0.2	N/A
Silicon	N/A	N/A	0.3
Sulfur	Trace	N/A	N/A
Iron	82.2	1.6	73.2
Copper	1.1	86.8	4.4
Spectrum	Figure 5	Figure 8	Figure 9

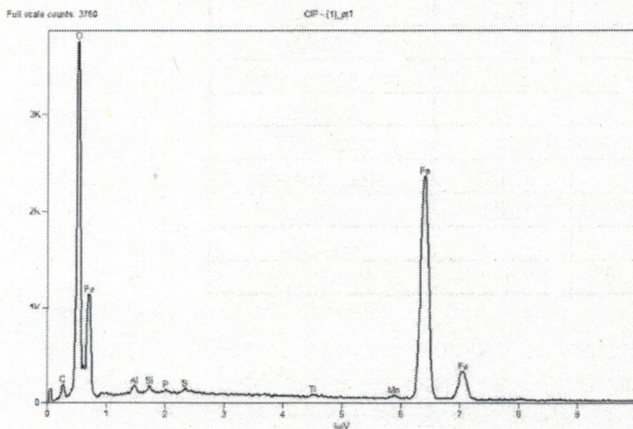
Figure 12 – Spectrum of CIP Area 1, Location 1

CIP Sediment Analysis Area 1 (Percent by Weight)					
Element/Location	1	2	3	4	5
Carbon	2.4	1.4	1.3	1.6	53.7
Oxygen	31.5	23.3	26.4	18.8	23.5
Aluminum	0.7	0.3	0.3	0.4	0.4
Silicon	0.5				
Phosphorous	0.2				
Sulfur	0.1				
Titanium	0.2				
Manganese	0.8		1.1		
Iron	63.7	74.0	70.3	2.6	20.4
Copper		1.0	0.5	76.6	2.0
Spectrum	Figure 12	Figure 13	Figure 14	Figure 15	Figure 16

Location 1 appears to be a piece of carbon steel. Aluminum and titanium are often used as grain refiners in steel. Locations 2 and 3 are iron oxide nodules. Location 4 is a piece of copper oxide scale. Location 5 is an iron rich organic material. Each of these particles were formed as a result of corrosion in the system. A likely source of the aluminum is the steel piping and tubing in the system.

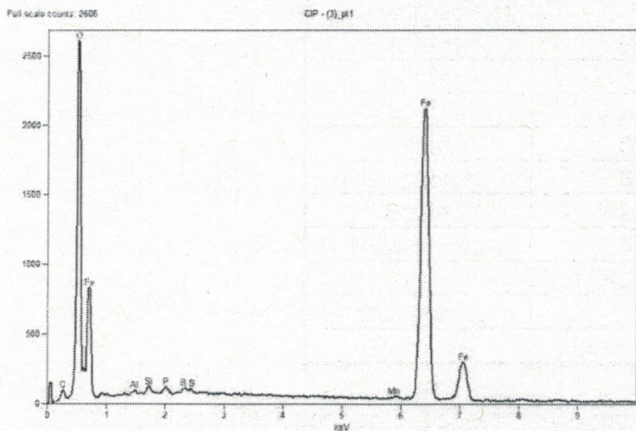
Figure 19 – Spectrum of CIP Area 2, Location 1

CIP Sediment Analysis Area 2 (Percent by Weight)			
Element/Location	1	2	4
Carbon	1.6	0.9	2.4
Oxygen	27.1	29.0	19.9
Aluminum	0.3	0.7	0.6
Silicon	0.6		
Phosphorous	0.5		
Sulfur	0.2		
Manganese	0.5		
Iron	69.2	68.9	1.9
Copper		0.5	75.2
Spectrum	Figure 19	Figure 20	Figure 21

The hollow nodule, Location 1, appears to be oxidized steel. Location 2 is iron oxide, and Location 4 is a group of copper oxide crystals. Aluminum was present in all three locations.

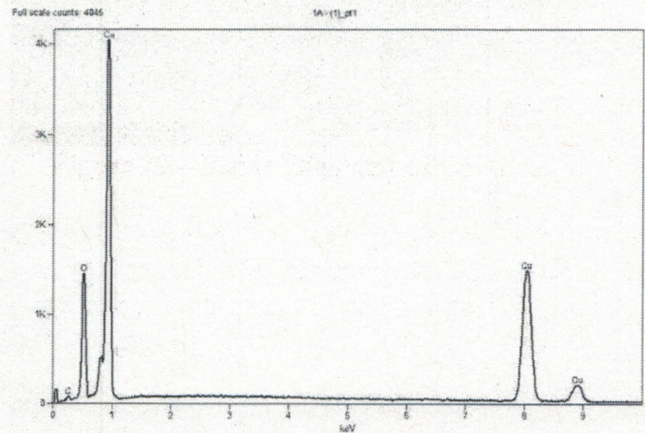
Figure 31 – Spectrum of Surface Shown in Figure 30
Coil Sample 1

tubing is ammonia. Figure 31 is the spectrum of the surface shown in Figure 30. Only three elements are present: carbon, oxygen, and copper. Ammonia and other nitrogen compounds are very hard to detect by energy dispersive x-ray analysis, but the intergranular cracking is a key indicator that they were present.

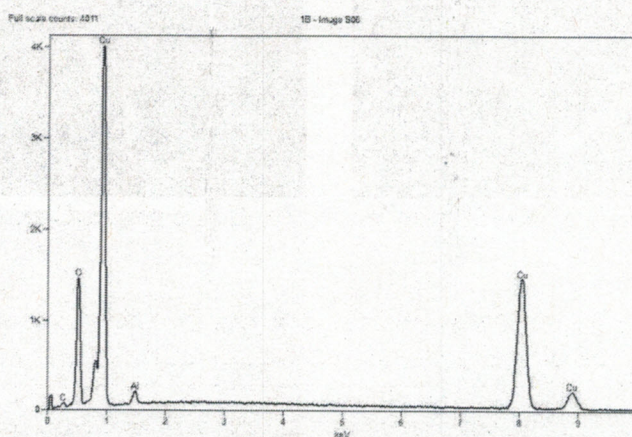
The intergranular cracking on the inside diameter of Coil Sample 1 is clearly shown in Figure 32. Figure 33 shows the nature of the oxide formation on the inside diameter of Coil Sample 1. Figure 34 is the energy dispersive x-ray spectrum of the surface area shown in Figure 32. This was the only location where aluminum was detected on the inside diameter of the copper tubing. The other elements were carbon, oxygen, and copper.

Figure 34 – Spectrum of the Surface Shown in Figure 32

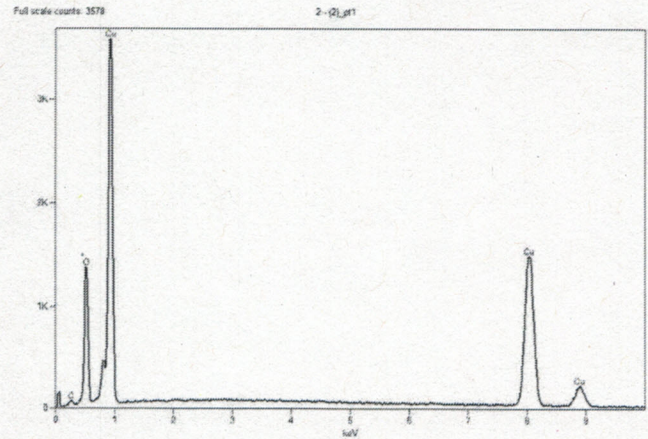
Figure 36 – Spectrum of Surface shown in Figure 35

Figure 35 shows a location on the inside diameter of Coil Sample 2. The thick oxide scale had flaked off the copper at this location. There was evidence of erosion and evidence of intergranular cracking present. Figure 36 shows the spectrum of the area shown in Figure 35. The elements present were carbon, oxygen, and copper.
